UNITED STATES ENVIRONMENTAL PROTECTION AGENCY  
REGION 6  
1445 ROSS AVENUE, SUITE 1200  
DALLAS TX 75202-2733

Enclosed please find the Sanitary Survey report for the Firelake Grand Casino Water System (PWS#061020808). A Sanitary Survey is a comprehensive evaluation of the source, pumps and pumping facilities, treatment, distribution (including storage facilities), laboratory facilities, management and operator qualifications at a public water system. The report contains a section entitled "Deficiencies" that lists deficiencies and recommendations, split into the following categories:

# EPA Region 6 Sanitary Survey Form System Information and Contacts

<b>PWSS Number</b>	<b>Water System Name</b>	<b>Date</b>
061020808	Firelake Grand Casino Water System	11/20/13
<b>Basic System Information</b>		
<b>Recommended Certification Level</b>		
ODEQ level 3		
<b>System Classification (C-NTNC-NC)</b>	<b>Service Area Type Code</b>	<b>Seasonal (Y/N)</b>
C	R	N
		<b>Seasonal Begin Date</b>
		N/A
		<b>Seasonal End Date</b>
		N/A
<b>Legal Entity</b>	<b>Name</b>	<b>Address</b>
<b>Administrative Contact</b>	Richard Kunze Public Works Director	1601 South Gordon Cooper Dr. Shawnee, OK 74801
<b>Operato

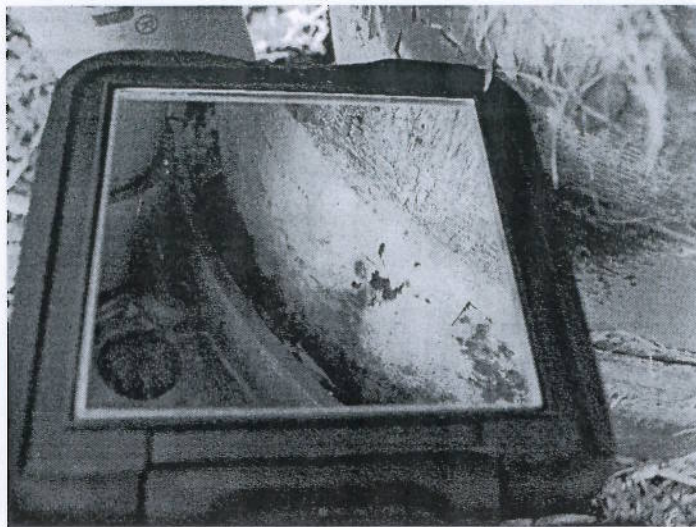
Small Hole next to Screen at  
well K2

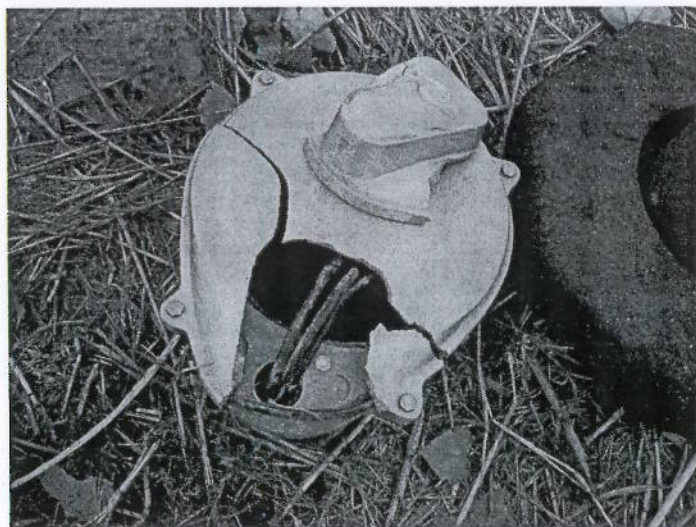
\*\* The well cap is broken.

Well K3 showing broken well cap

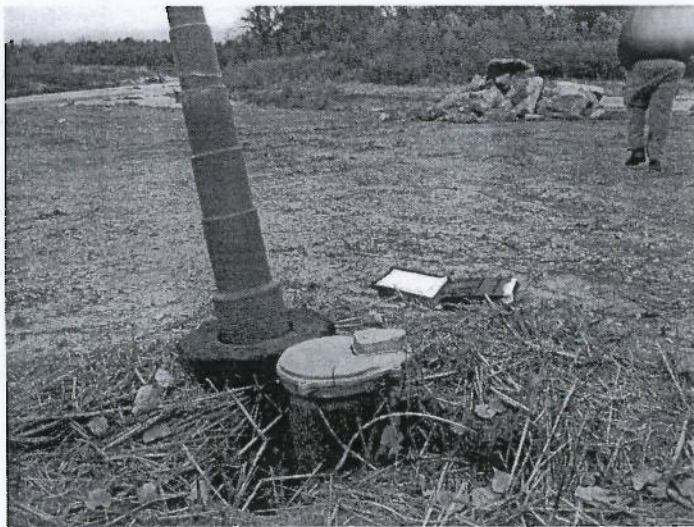
Well K3 showing distance to  
River and height of casing

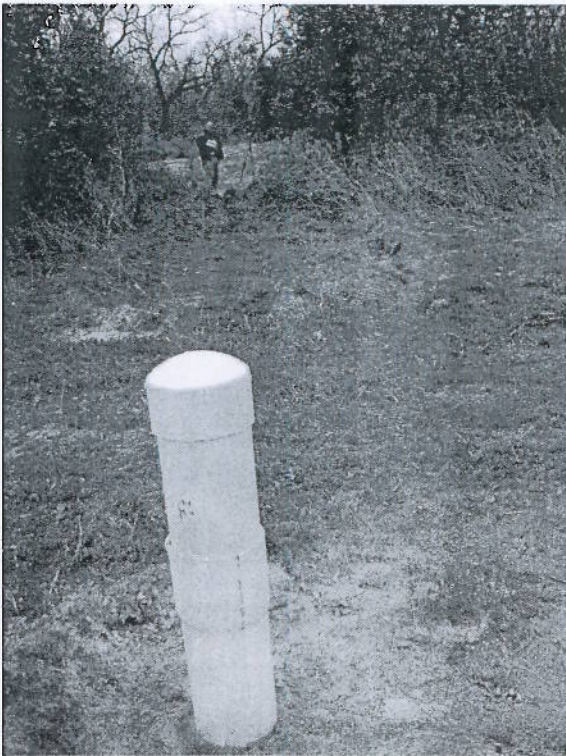
Well K4 casing showing  
distance to river

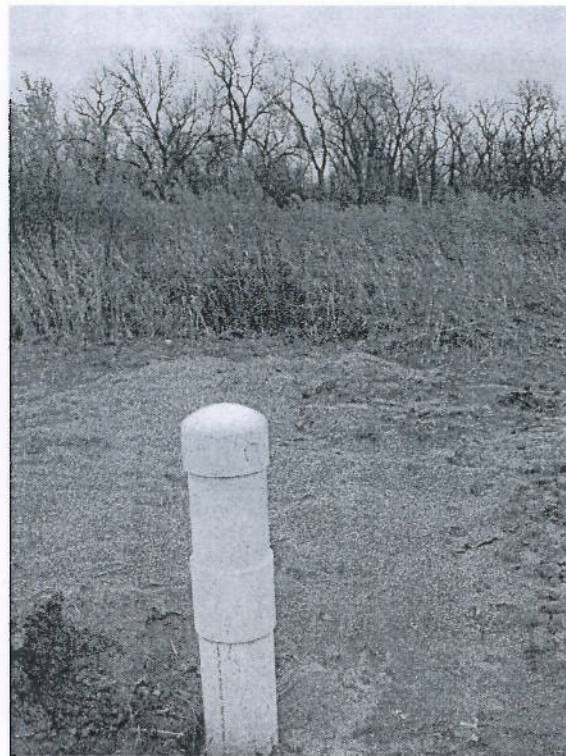
Well K5 casing showing  
distance to river

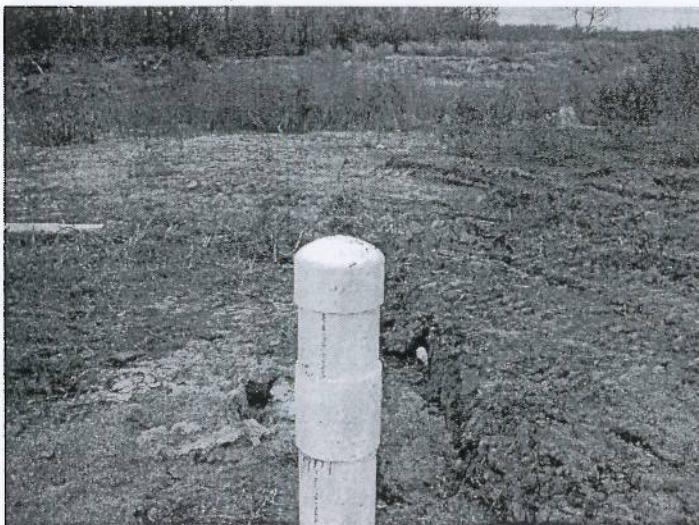
Well K6 casing showing distance  
to river

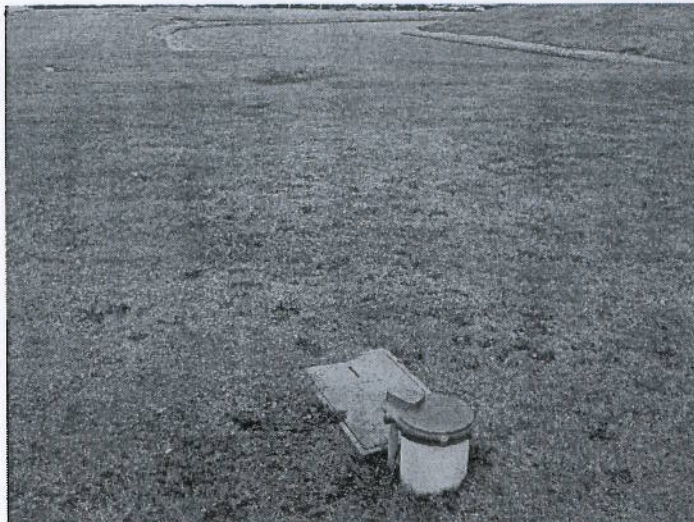
South Well with Geothermal pond in background and showing casing height

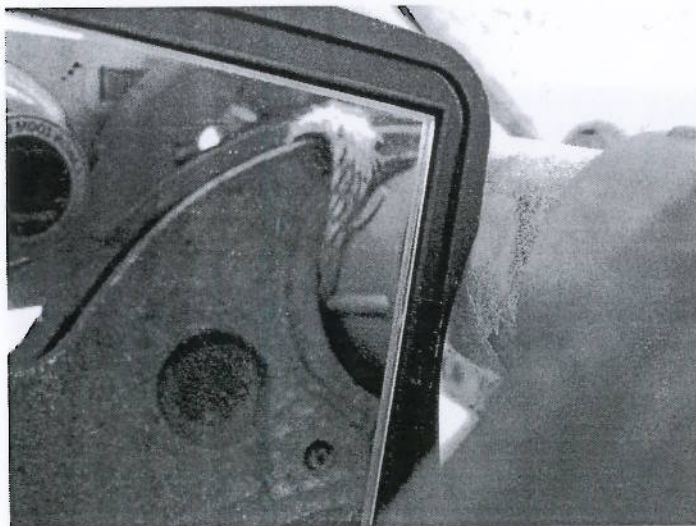
South well showing gap where rope enters the well head

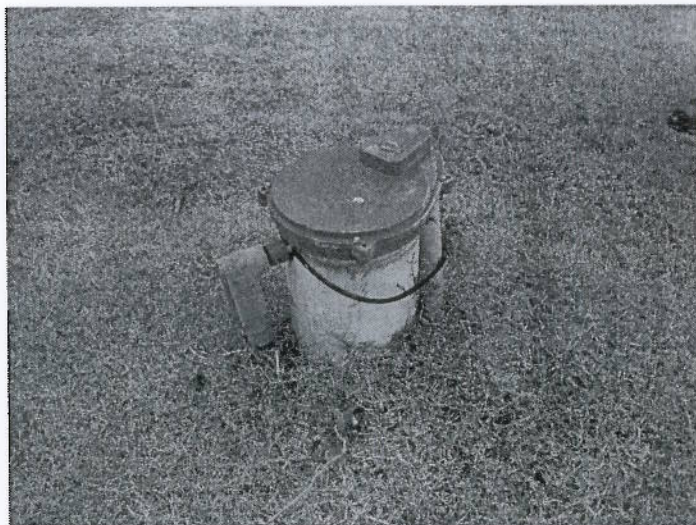
North well showing casing height and electrical conduit on two sides.

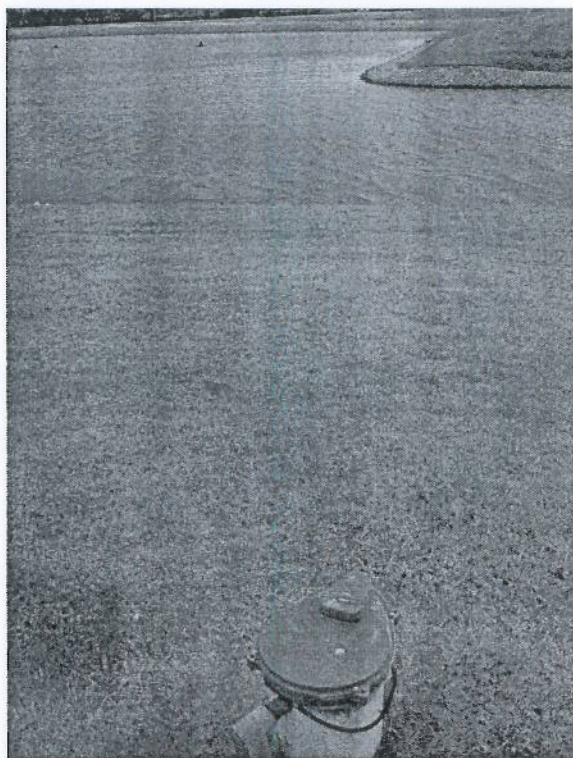
North well showing  
proximity to geothermal  
pond

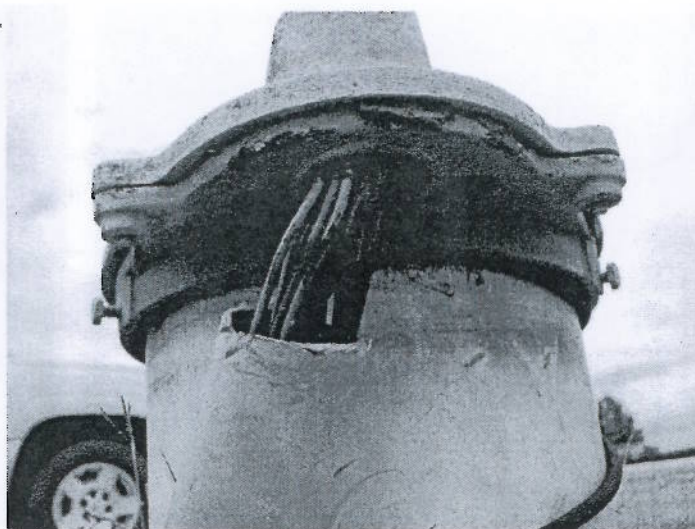
North well showing gap where  
electrical lines enter on one side

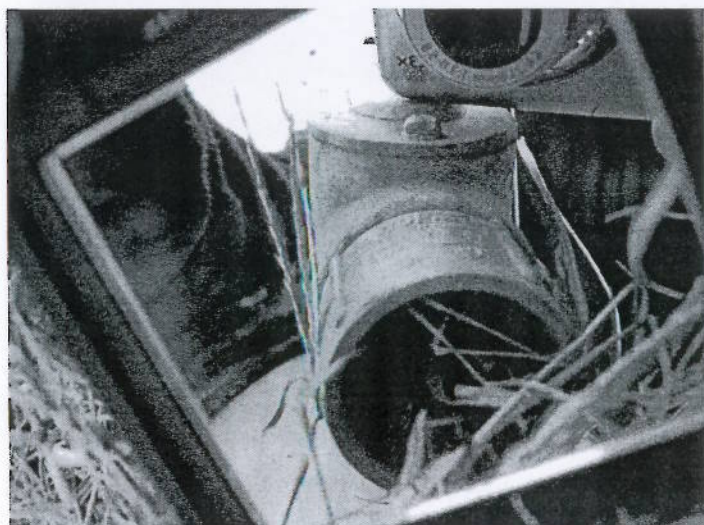
North well showing gap where  
electrical lines enter the other  
side

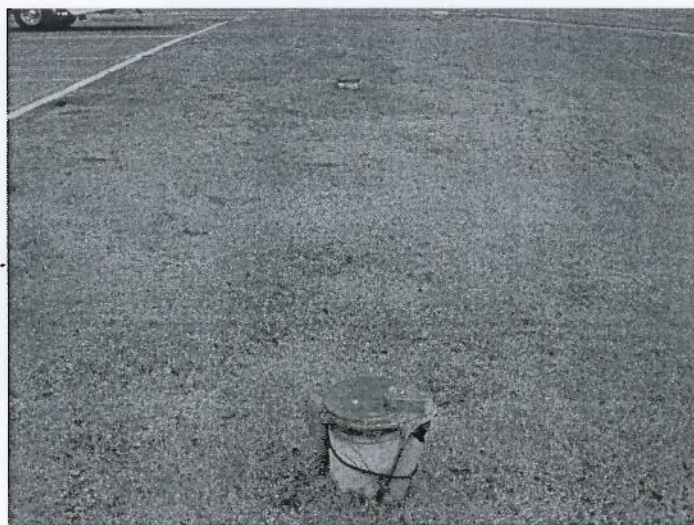
North well showing nearby  
abandoned well

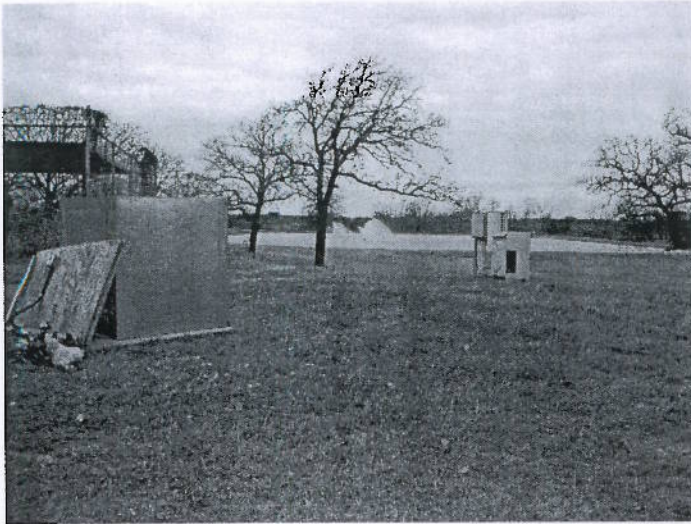
Well 3 well house showing  
proximity to waste water pond

Sources	
Well 3 and Well 4	The wells are within 400 feet of a treated wastewater pond. (Plans for future wells should be submitted to EPA prior to construction to prevent similar situations.)
Batch Plant East Well	There is no screen on the Batch Plant East well air relief valve, however the well is inactive. The screen needs to be fixed before activation.
	The well cap is loose on the Batch Plant East well (inactive well needs to be corrected before being activated). It also has a hole where the electrical line enters.
Management	There is no emergency plan for the PWS (There was no previous requirement for an emergency plan but this survey will change the water system classification to <i>community</i> ).
Storage	There is no gasket on the raw/gray or finished water 20K gallon storage tank hatch lids.

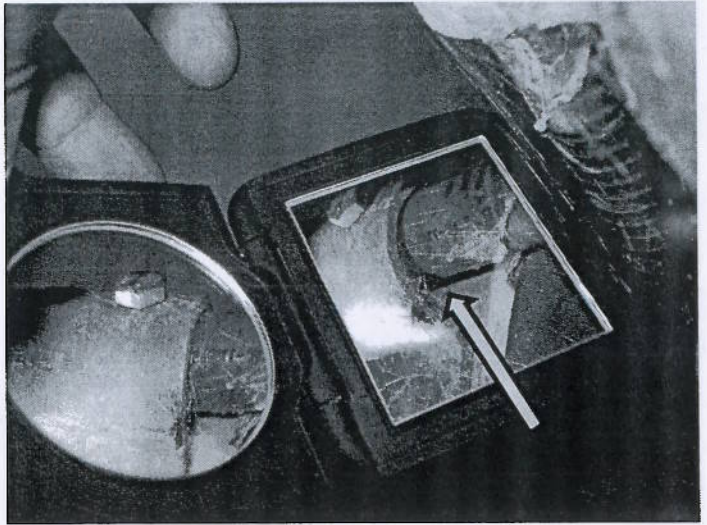
Well 3 gap where electrical line  
enters well head

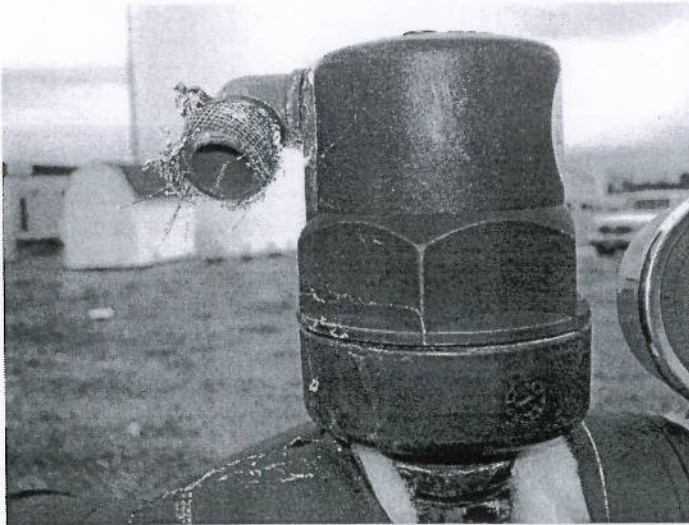
Torn screen on air relief valve at  
Well 3

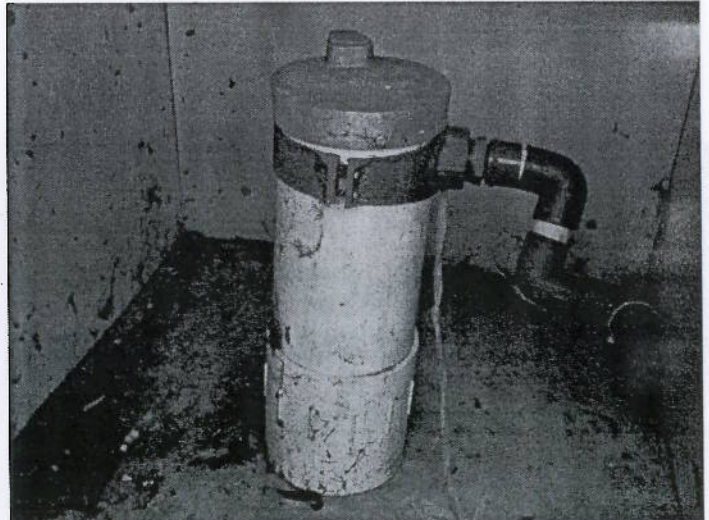
Well 3 showing vent not turned  
over and too low

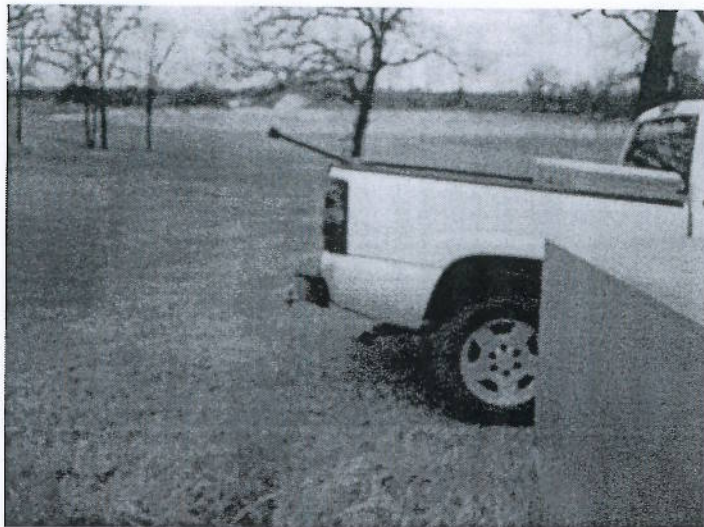
Well 4 well house showing proximity to waste water pond.

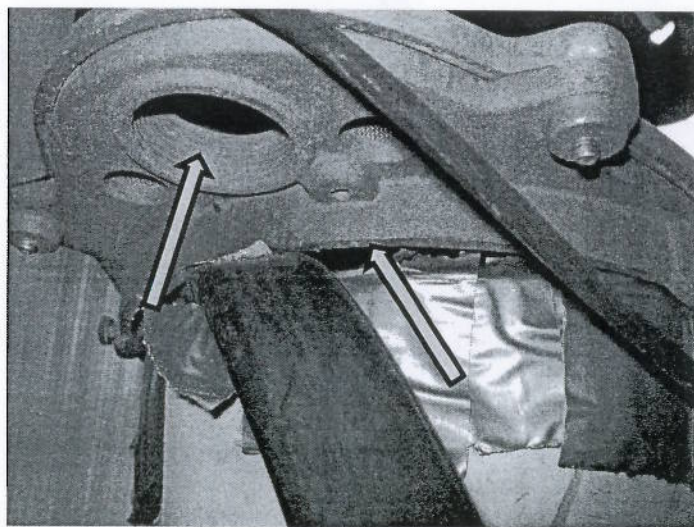
Batch Plant East Well loose well cap and hole at electrical line

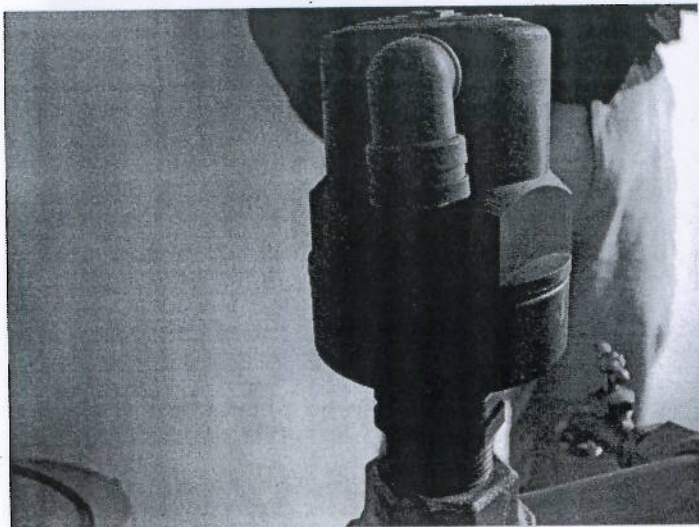
Batch Plant East Well Air relief valve unscreened

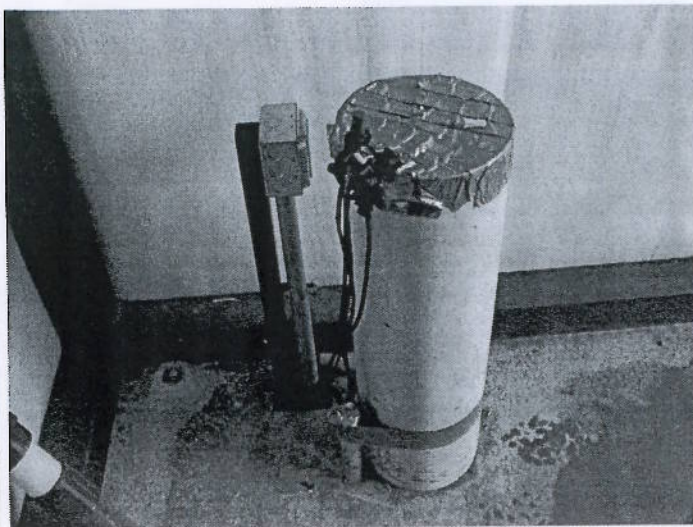
\* The well head is missing the cap and is sealed with duct tape.

Batch Plant West Well showing duct tape cap, hole where electrical lines enter and lack of electrical conduit

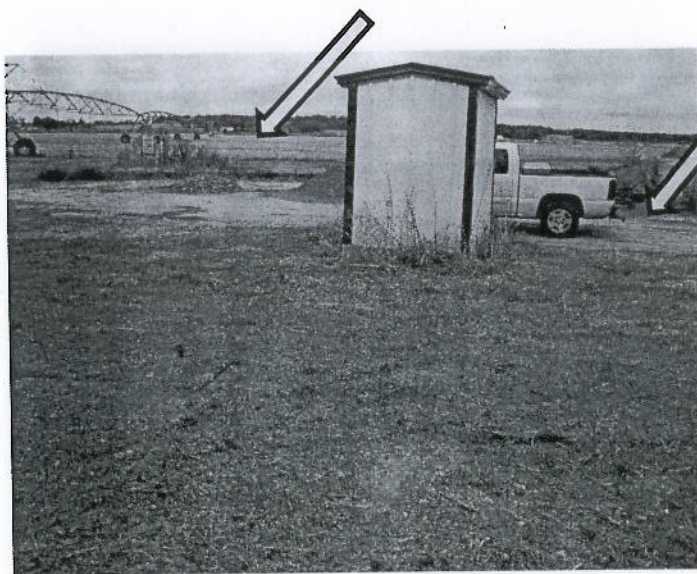
Batch Plant West well house adjacent to parking area and grass farming operations

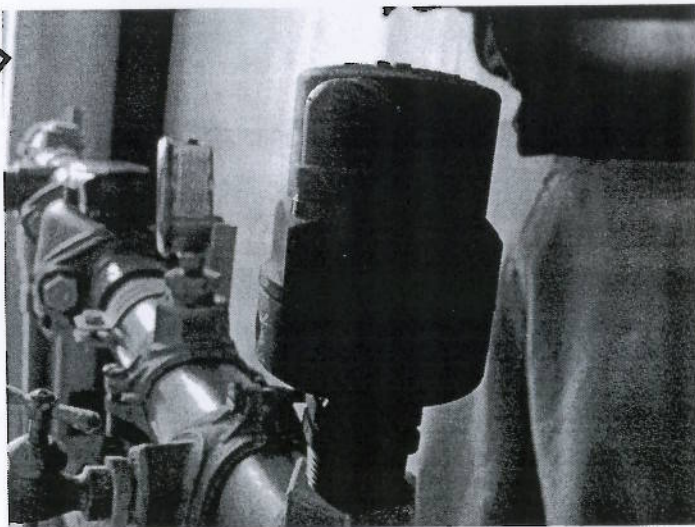
Unscreened air relief valve at Batch Plant West Well

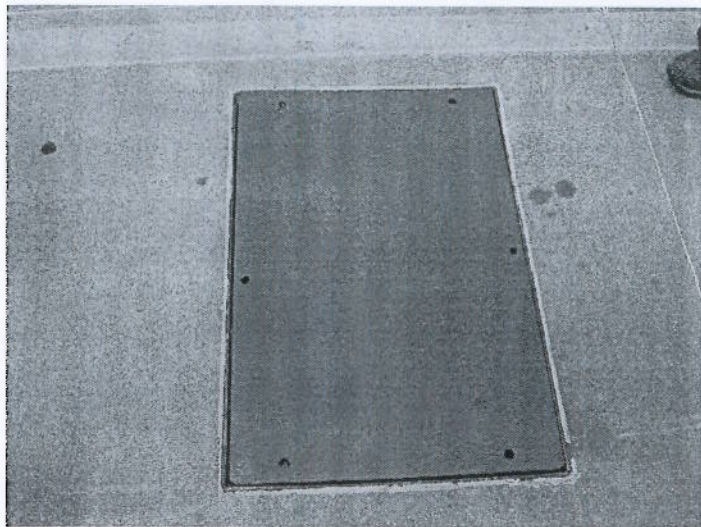
Roadway well vault in Road

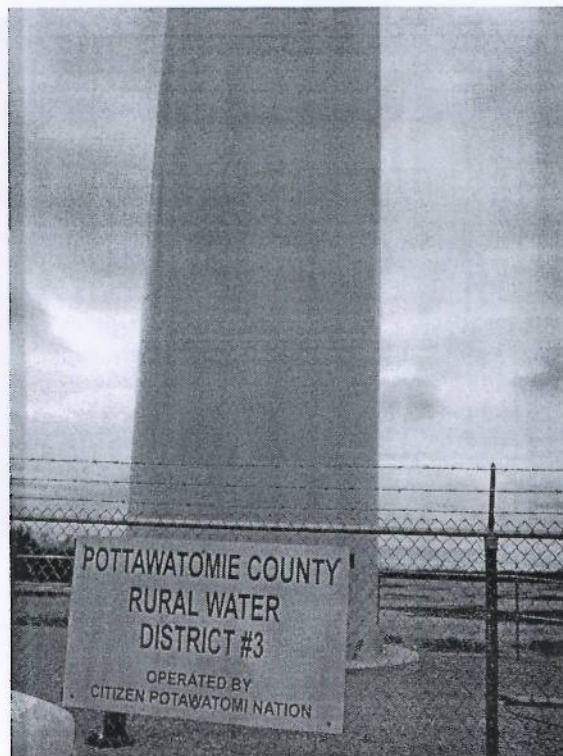
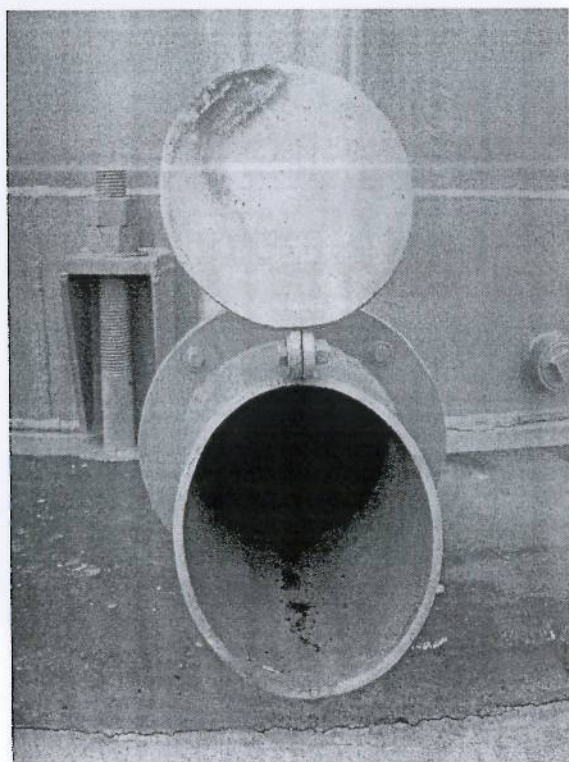
Coker standpipe overflow  
showing some iron precipitate
